POTENTIAL HAZARDOUS WASTE SITE
SITE INSPECTION REPORT

REGION 6	SITE NUMBER (to be assigned by HQ) TX02496
-------------	---

A. SITE NAME Chemical Recycling, Inc. (aka JR Siemoneit)		B. STREET (or other identifier) 802 Kirby St.	
C. CITY Wylie	D. STATE TX	E. ZIP CODE 75098	F. COUNTY NAME Collin
G. SITE OPERATOR INFORMATION 1. NAME James Robert Siemoneit, President, Wylie, TX 75098		2. TELEPHONE NUMBER 214/442-5495	
3. STREET 802 Kirby St.	4. CITY Wylie	5. STATE TX	6. ZIP CODE 75098
H. REALTY OWNER INFORMATION (if different from operator of site) 1. NAME Same		2. TELEPHONE NUMBER Same	
3. CITY		4. STATE	5. ZIP CODE
I. SITE DESCRIPTION (chlorinated hydrocarbons, paint wastes, printing ink wastes) Reclamation of solvents by distillation			
J. TYPE OF OWNERSHIP <input type="checkbox"/> 1. FEDERAL <input type="checkbox"/> 2. STATE <input type="checkbox"/> 3. COUNTY <input type="checkbox"/> 4. MUNICIPAL <input checked="" type="checkbox"/> 5. PRIVATE

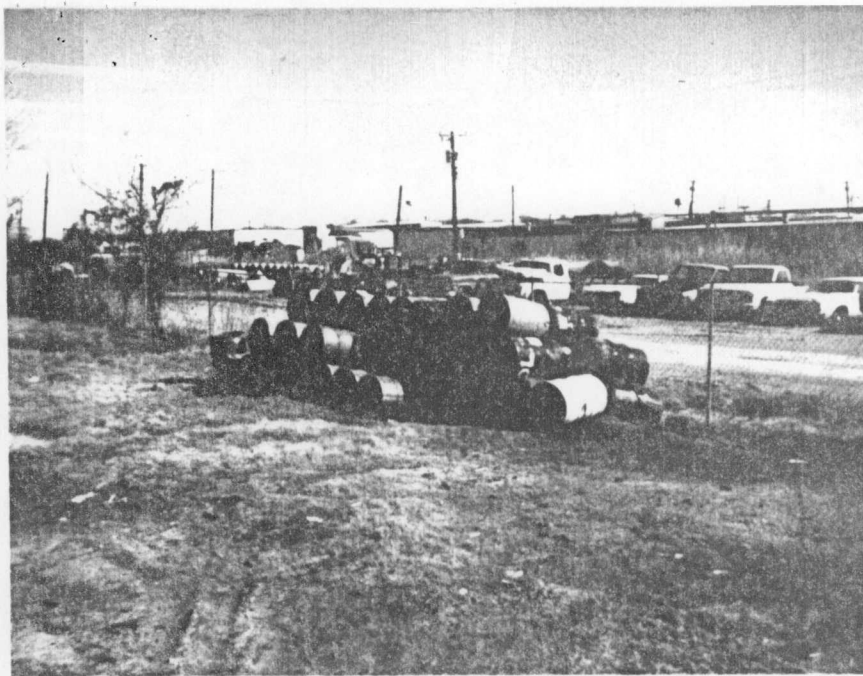
Comments: Stack of ~50 empty
drums on east boundary.
Drums are to be reconditioned
off site

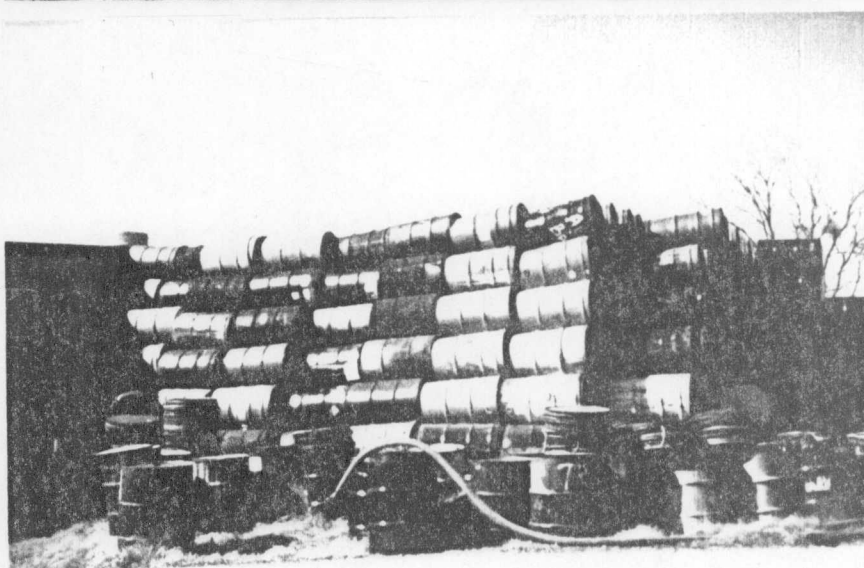
Comments: Stack of ~400
empty drums adjacent to
whse. Drums to be
reconditioned off-site.

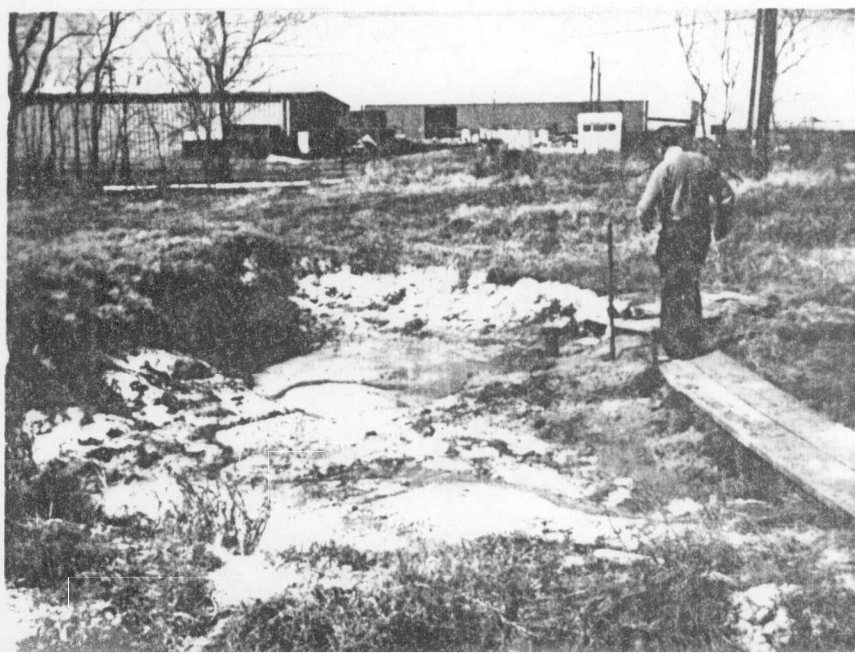
Comments: Process area catchment
basin which drains by underground
pipng to sanitary sewer

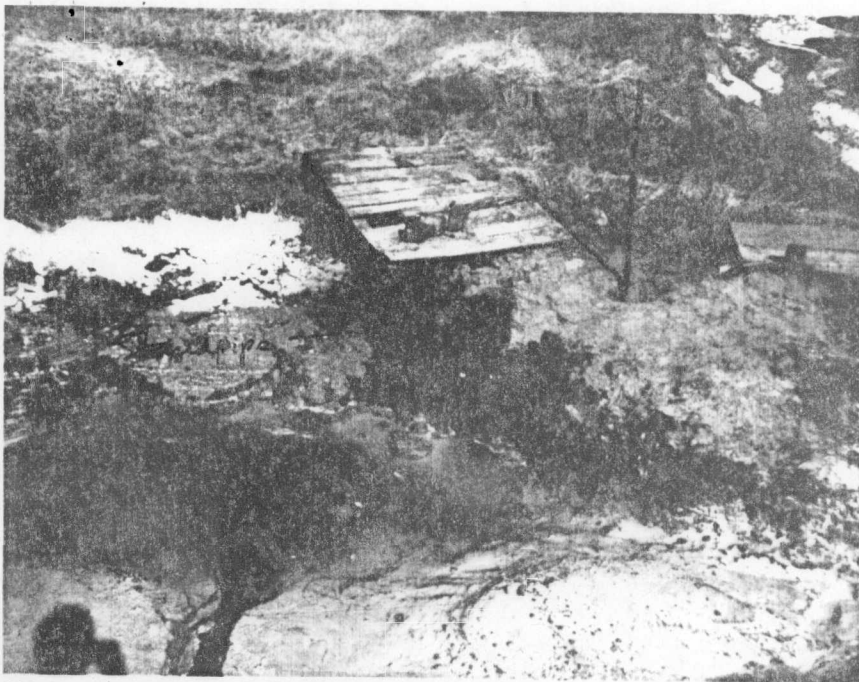
Valve is submerged immediately
below overflow stand pipe.

pH of standing water was 11.5

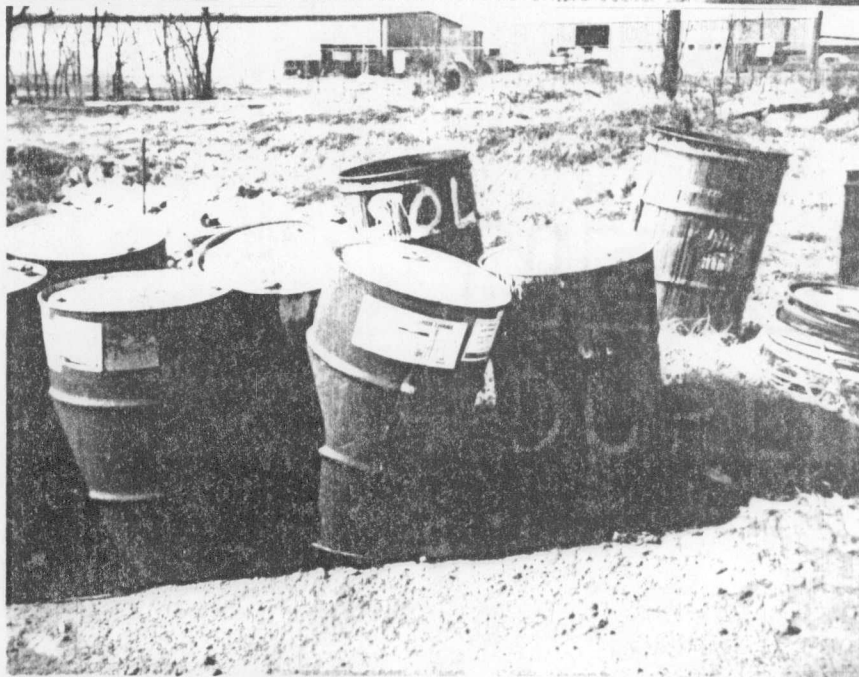
Comments: Partially filled in-
coming drums intended for
solvent recovery. Located SE
of process area.

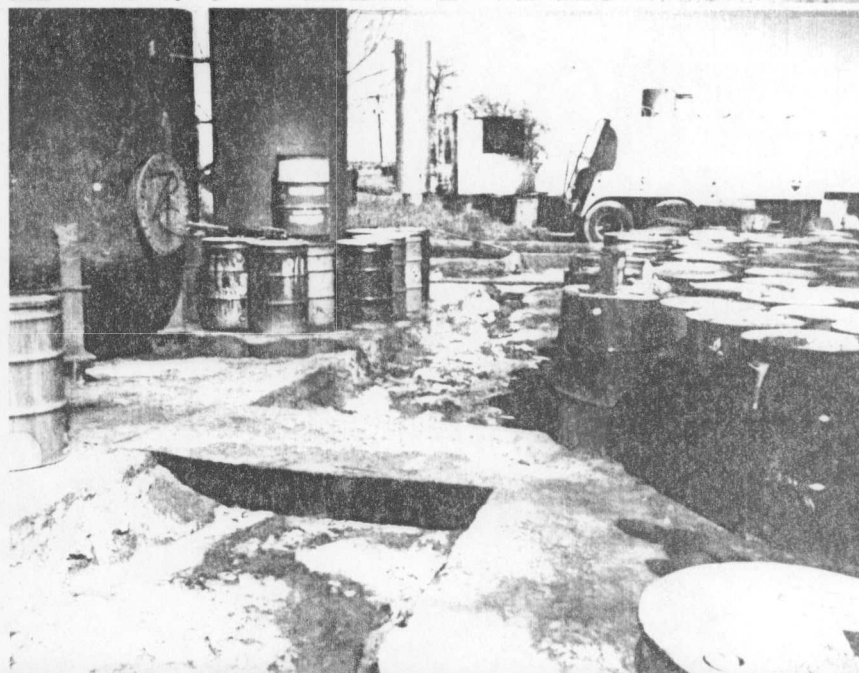
Comments: Process area on left.

Spill & runoff catchment channel
(unlined)

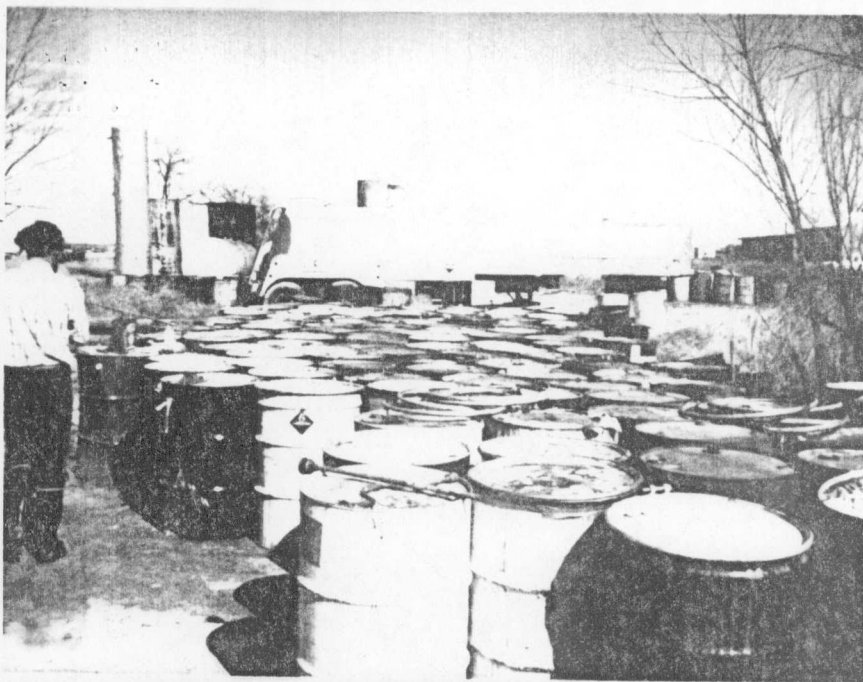
Comments: Still bottom waste
drums awaiting offsite
disposal.

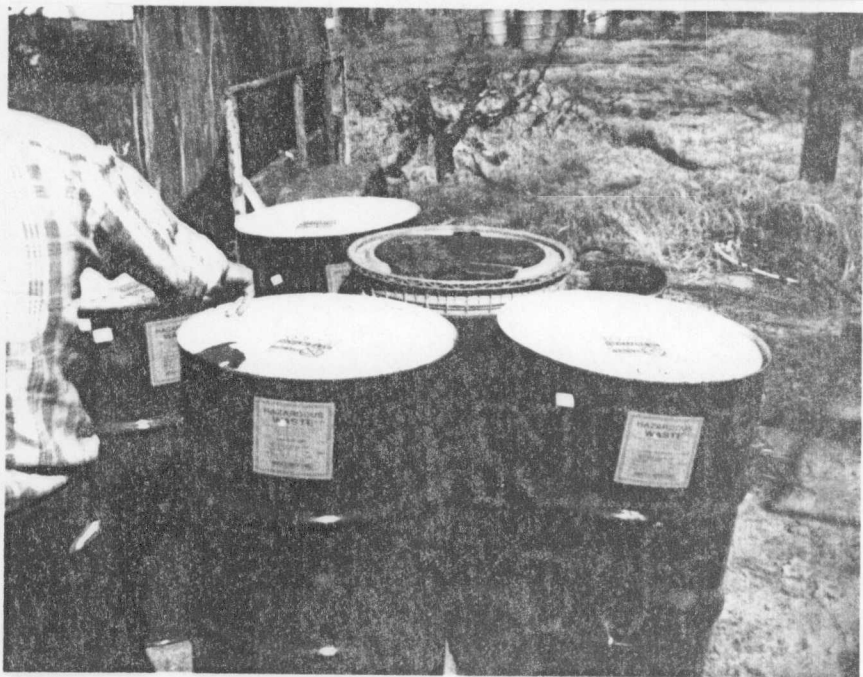
Comments: Full drums of isopropyl
alcohol awaiting processing.
Immediately west of process
area.

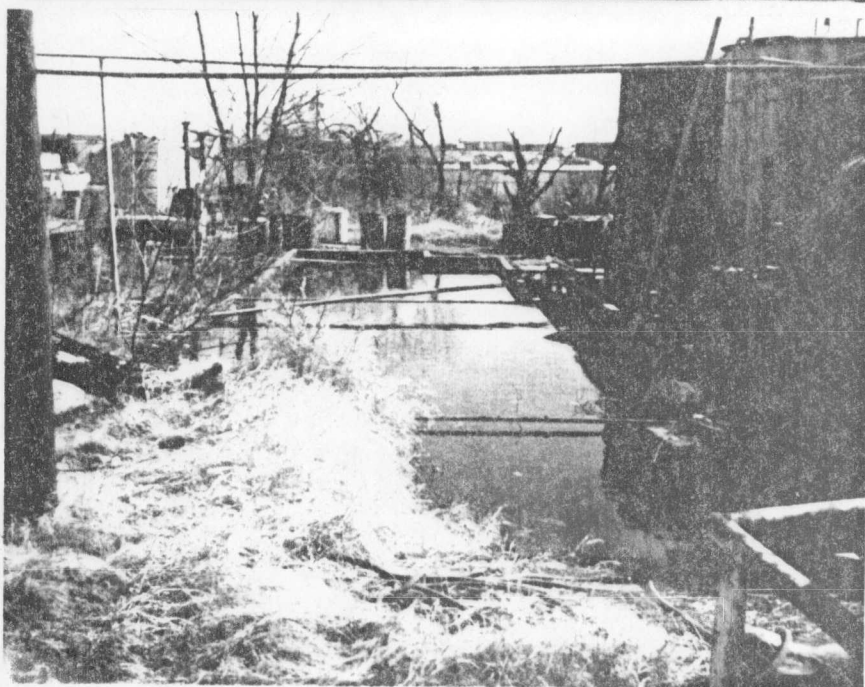
Immediately to the north of the process area, two inactive concrete drying beds filled with rainwater were observed. These beds are several feet in depth and have been inactive for several years, but still contain waste solids beneath the rainwater, according to the TDWR District field representative. Less than a foot of freeboard was observed.

Comments: Inactive "drying beds"
filled with rainwater.
Immediately north of process
area

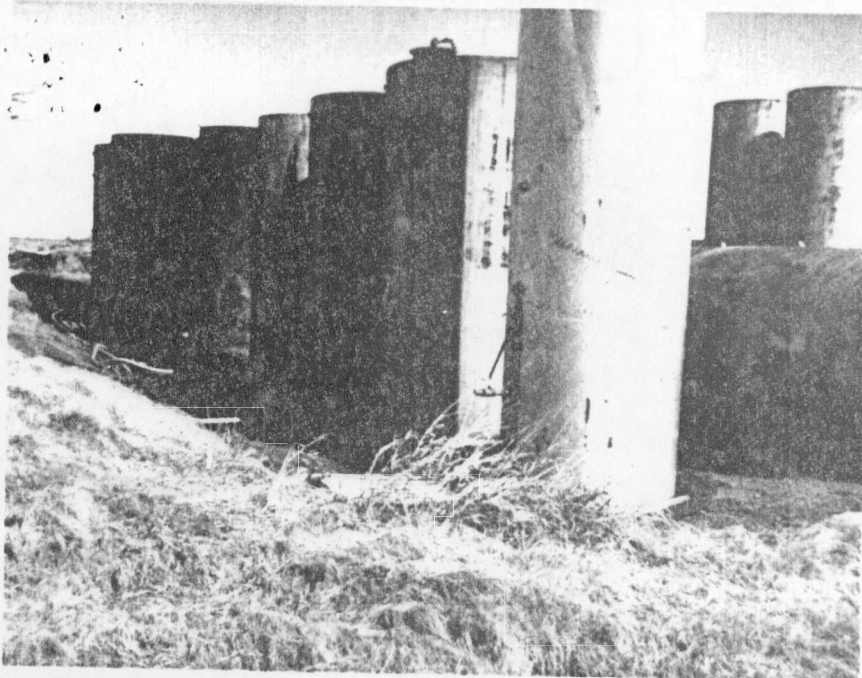
Comments: Diked tank farm

area.

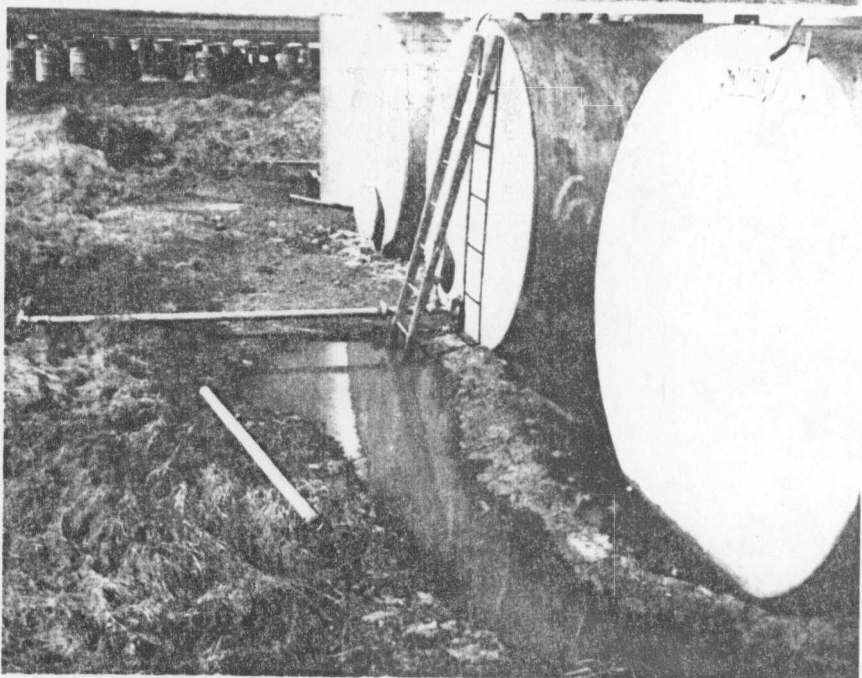
The tank farm was viewed next. This area was diked and had standing water in the southeast corner and near the manual drain valve at the inside of the east berm. Mr. Siemoneit stated that the valve was opened only to relieve rainfall accumulation. The underground pipe discharged approximately 30 feet to the east in the designated drum storage area. A sample of the standing water taken from near the drain valve indicated that significant spillage of organics had occurred in the tank farm area. The water sample was determined to be hazardous by EP Toxicity criteria (Pb, 5.3 mg/l) and contained significant levels of identified alkylated and chlorinated organics (concentration range, 11.5 - 81.8 mg/l). Numerous unidentified organics were also determined to be present.

Comments: Standing water in
southeast corner of tank
farm.

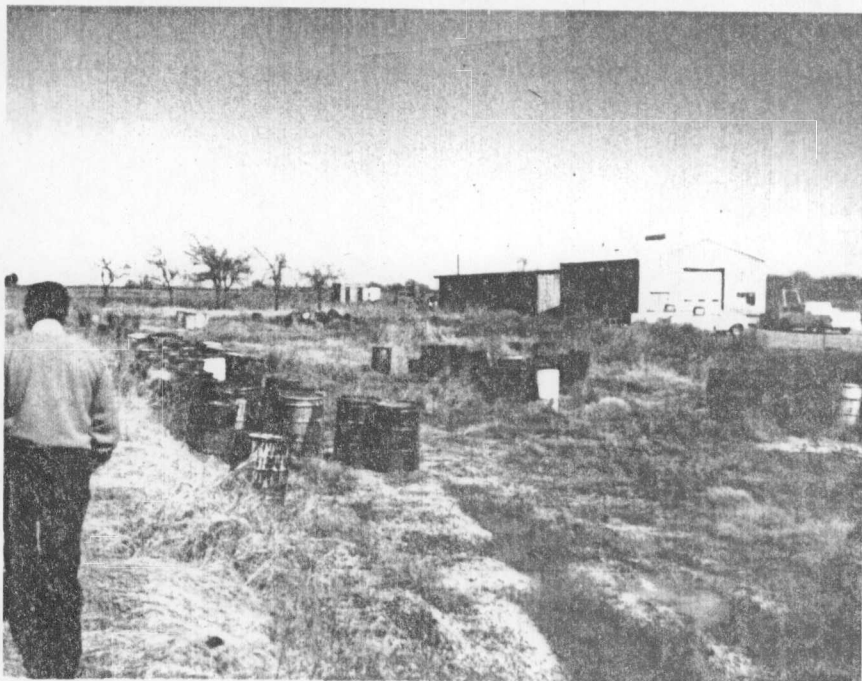
Comments: Designated drum
storage area. Low diking
was observed at perimeter.

At one time, this area held
~1200 drums.

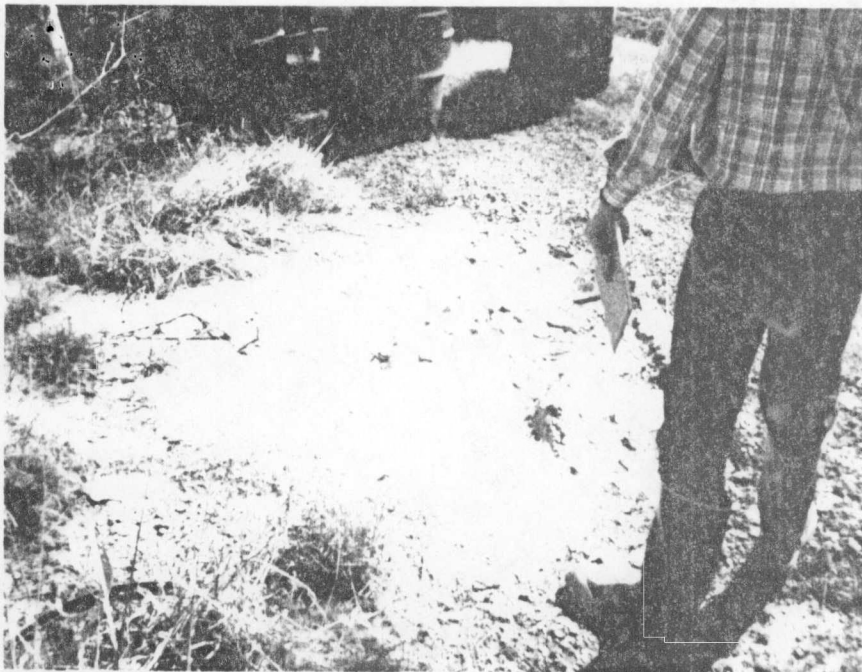
Catchment basin, tank farm, and drum storage areas not lined. Paint spillage was observed in drum storage area. Metals (Zn, Pb, Cr) and numerous identified and unidentified organics were determined to be present in the surface soils and catchment basin sediment.

Comments: Spilled paint on
surface soil in drum storage
area.

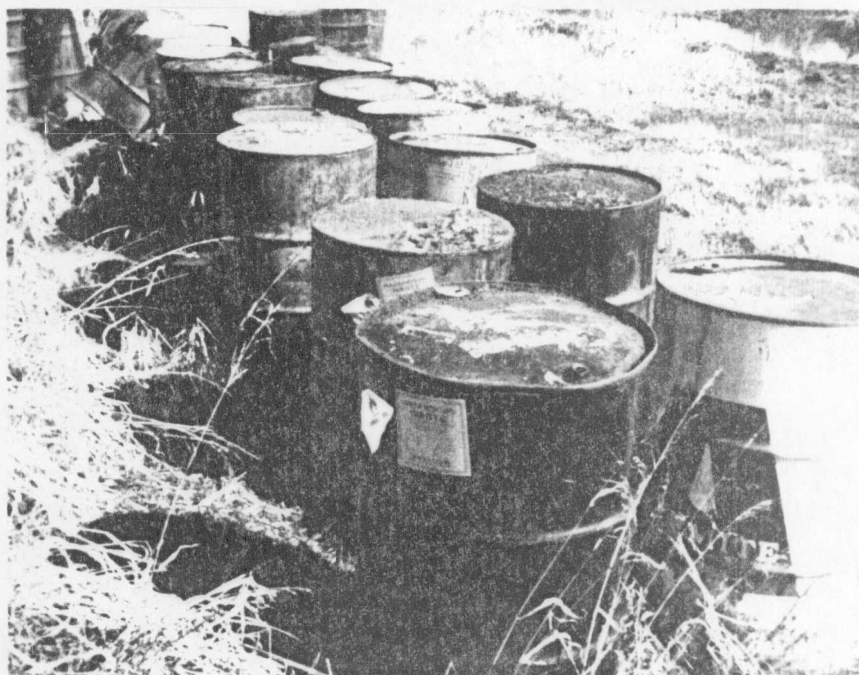
The drum storage area contained 200 to 300 drums in various conditions and content levels. Some were laying on their sides. Areas of spillage and leaking drums were noted, predominantly of paint wastes. Mr. Siemoneit informed us that at one time the area contained some 1,200 drums, most of which had been removed to a Class I landfill. This area is bounded by a poorly defined dike (lowest side, east) with estimated dimensions of 80' x 200'. Standing water with an oily film was noted in the southeast corner. A sample of this water showed the presence of numerous organics (many unidentified), including 4.52 mg/l of 1,2-dichloroethane. Some ponded water was also noted on the north part of the drum storage area.

Comments: Drums in various
conditions in drum storage area.

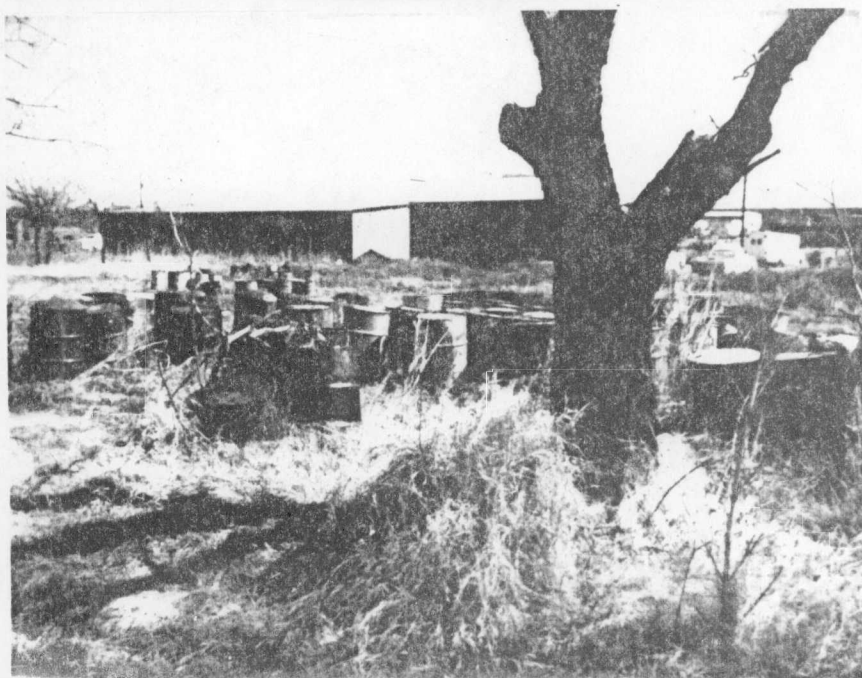
Comments: Miscellaneous drums
not inside drum storage area

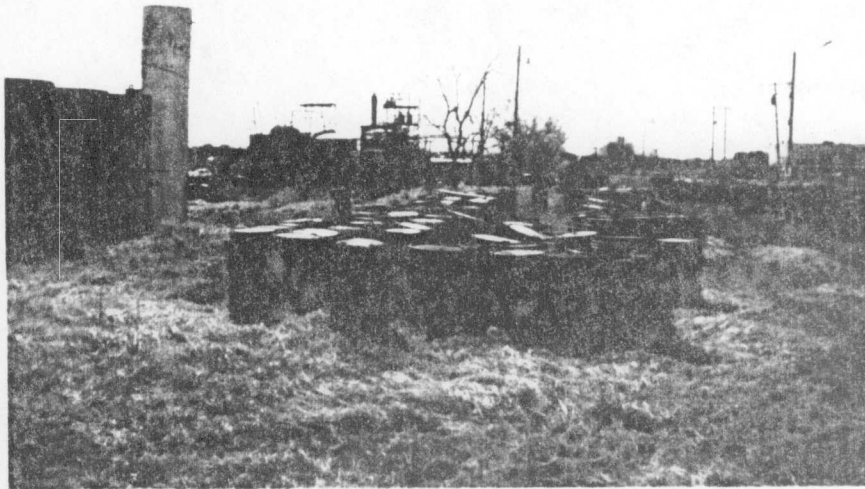
Approximately 700 drums were observed in an unpaved open area along the western edge of the property. Mr. Siemoneit stated that they contained dried paint still bottoms which he expected to sell to a sealant manufacturer for incorporation into product.

Comments: Looking across ~700
drums on west boundary. Drums
contain dried still bottoms
awaiting potential resale.

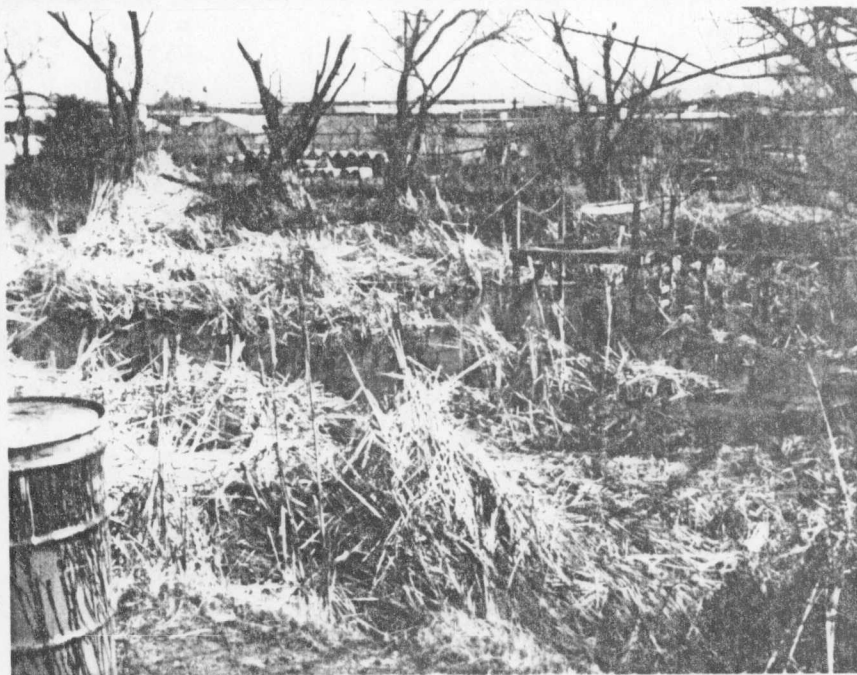
Comments: Natural pond on-site
Pond was overtaken by cattails
and bulrushes. Two ducks were
observed in water.

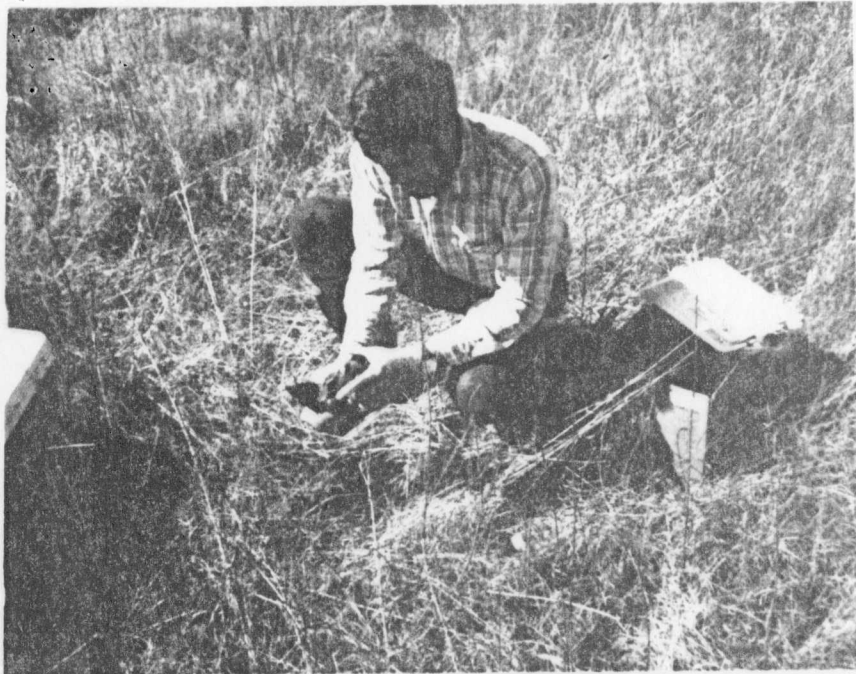
Comments: Collection of background
surface soil sample (TX02496-1)

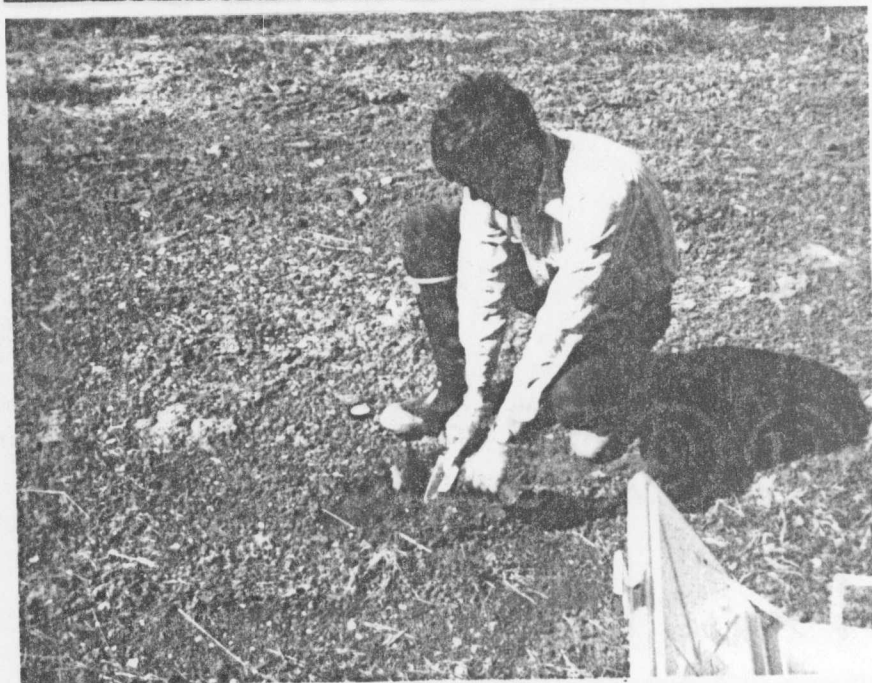
(TX02496-2)

Comments: Collection of surface
soil sample in landfarm area
on west boundary road.

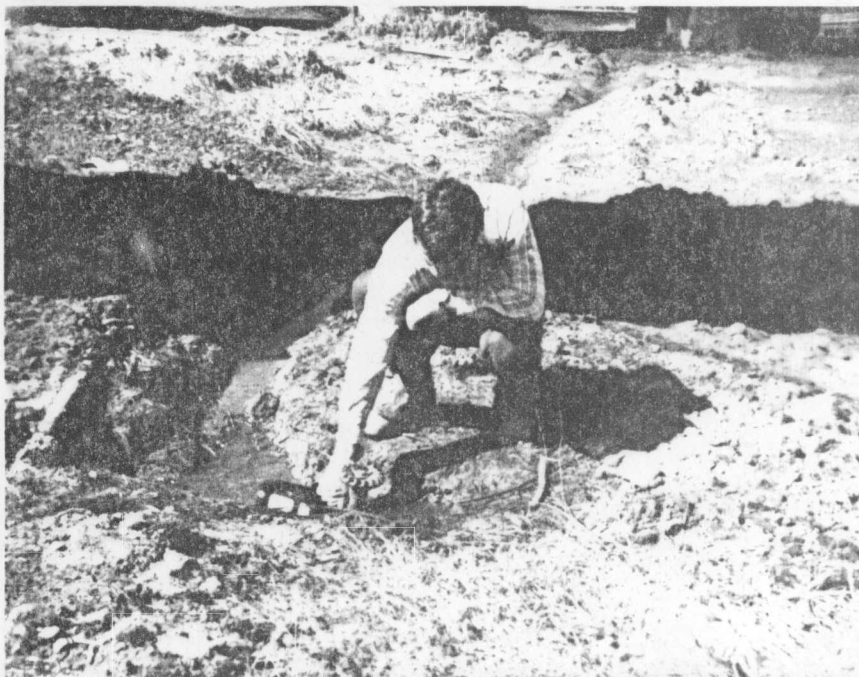
Comments: Collection of surface
water sample in tank farm near
drain pipe inlet. (TX02496-3)

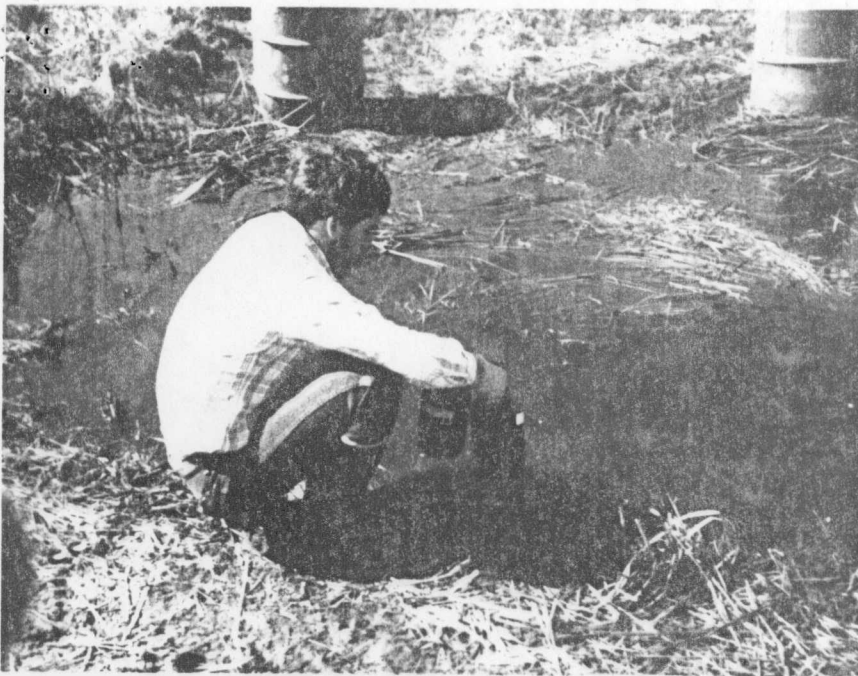
(TX 02496-4)

Comments: Collection of standing
water sample from SE corner of
designated drum storage area.

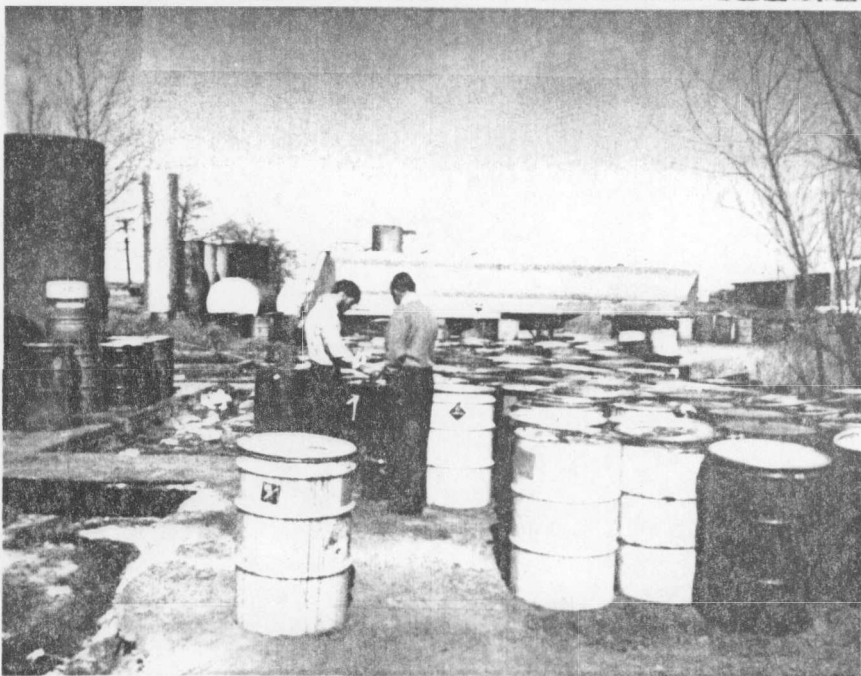
Comments: Collection of Waste sample
Dried still bottom waste from top
of drum (TX 02496-5)

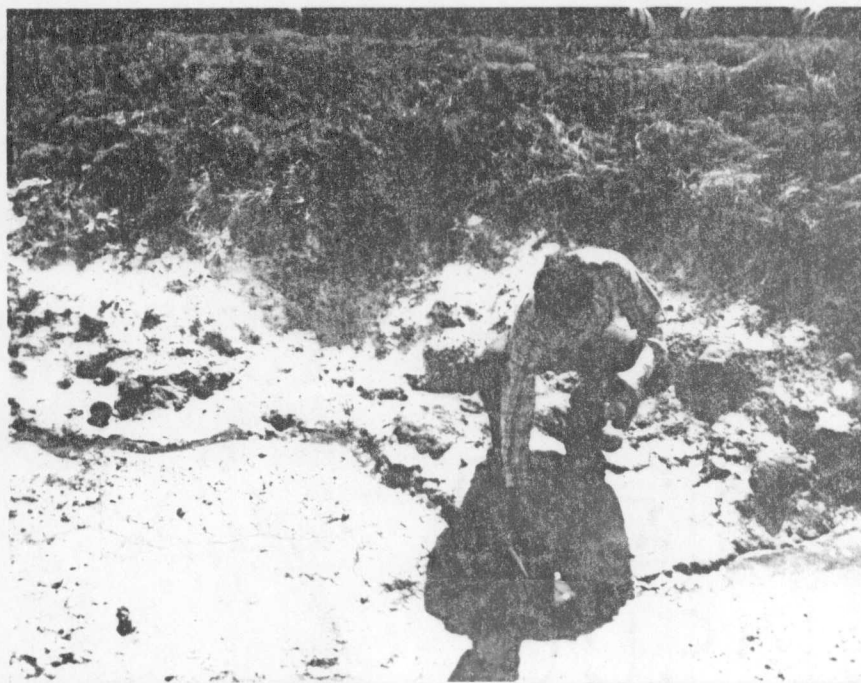
(TX 02496-6)

Comments: Collection of Sediment
Sample in Catchment basin immediate
South of process area.

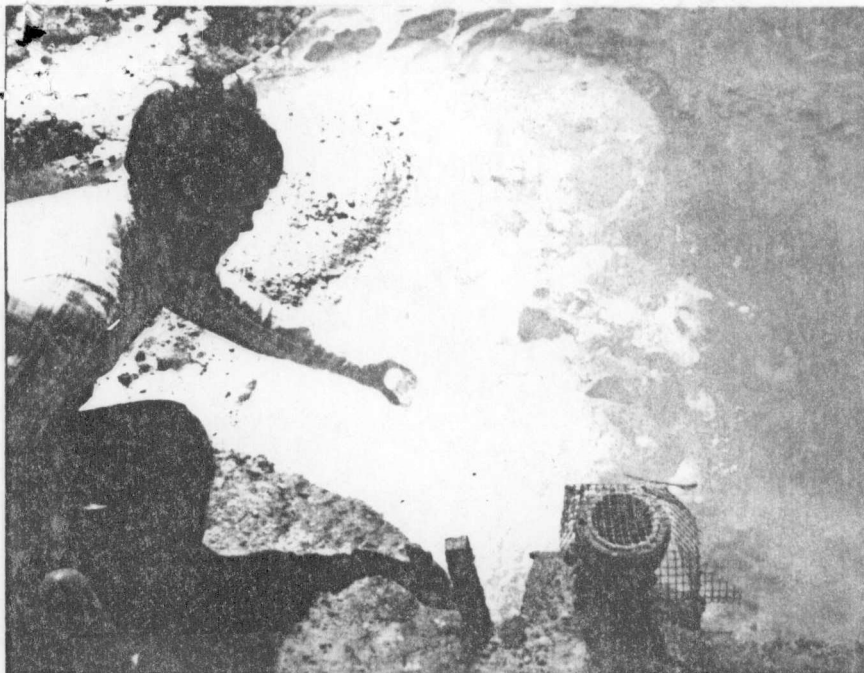
Comments: Collection of water
sample in catchment basin
(TX - 02496-7)

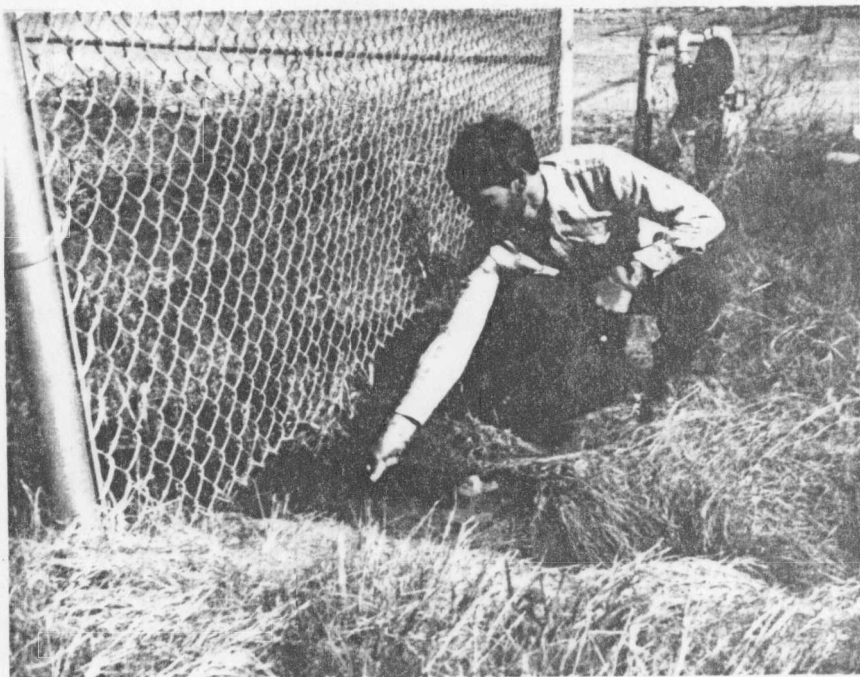
The collection of off-site samples included standing water and sediment from the eastern adjacent ditch which conveys uncontained site runoff to a tributary of Muddy Creek. The sediment in this ditch had levels of Pb, Zn, and Cr which exceeded background soil levels by 27, 3, and 6 times, respectively. Water in the ditch was found to contain insignificant levels of metals but measurable concentrations of various identified and unidentified organic species.

Comments: Collection of runoff
water sample in ditch
along SE corner of site
(TX 02496-8)
